# MAUCH CHUNK LAKE DAM

PHASE I INSPECTION REPORT  
NATIONAL DAM INSPECTION PROGRAM

SEPTEMBER 1978

MAUCH CHUNK LAKE DAM  
CARBON COUNTY, PENNSYLVANIA  
NATIONAL I.D. NO. PA 00605

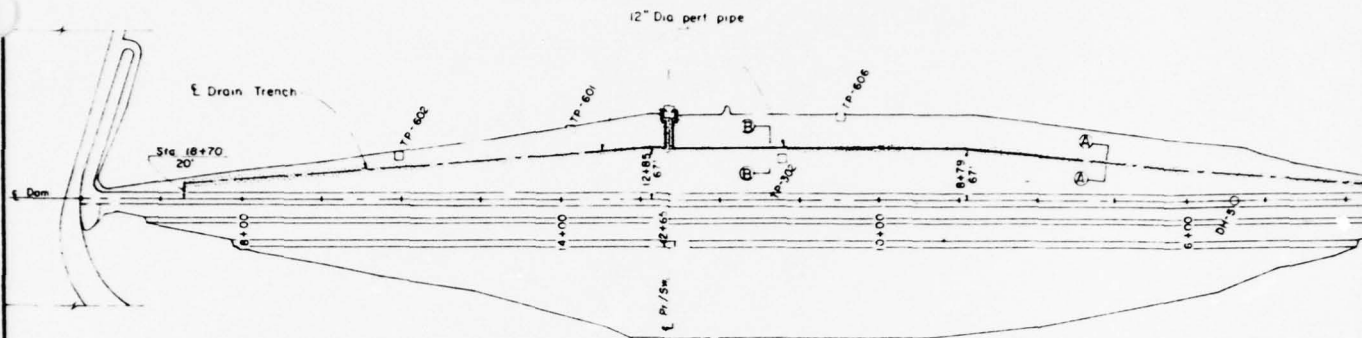
PLATE 3

The dam is a rolled earth embankment containing a cutoff trench and drainage trench. The drainage trench has a rectangular cross-section and is located downstream of the centerline. Plates 3 and 4 show the location of this trench. The purpose of the trench is to control embankment seepage. The water is discharged through two 6-inch diameter pipes into the impact basin at the downstream toe. The dam also contains a cutoff trench located under the centerline and a triple line grout curtain between Stations 9 + 50 and 13 + 70. Details of the grout curtain are shown on Plate 10 of Appendix E. The split spacing, stage grouting method was utilized where the upstream and downstream holes were drilled and grouted first. Holes were staggered 5 feet on center, and occasionally, the grout hole spacing was reduced to 2-1/2 feet on center.
